The Case of the Deadly Ground Wire

Current “jumping” across live phase conductor to severed ground wire on utility pole leads to fatality

Thomas McCauley, P.E.

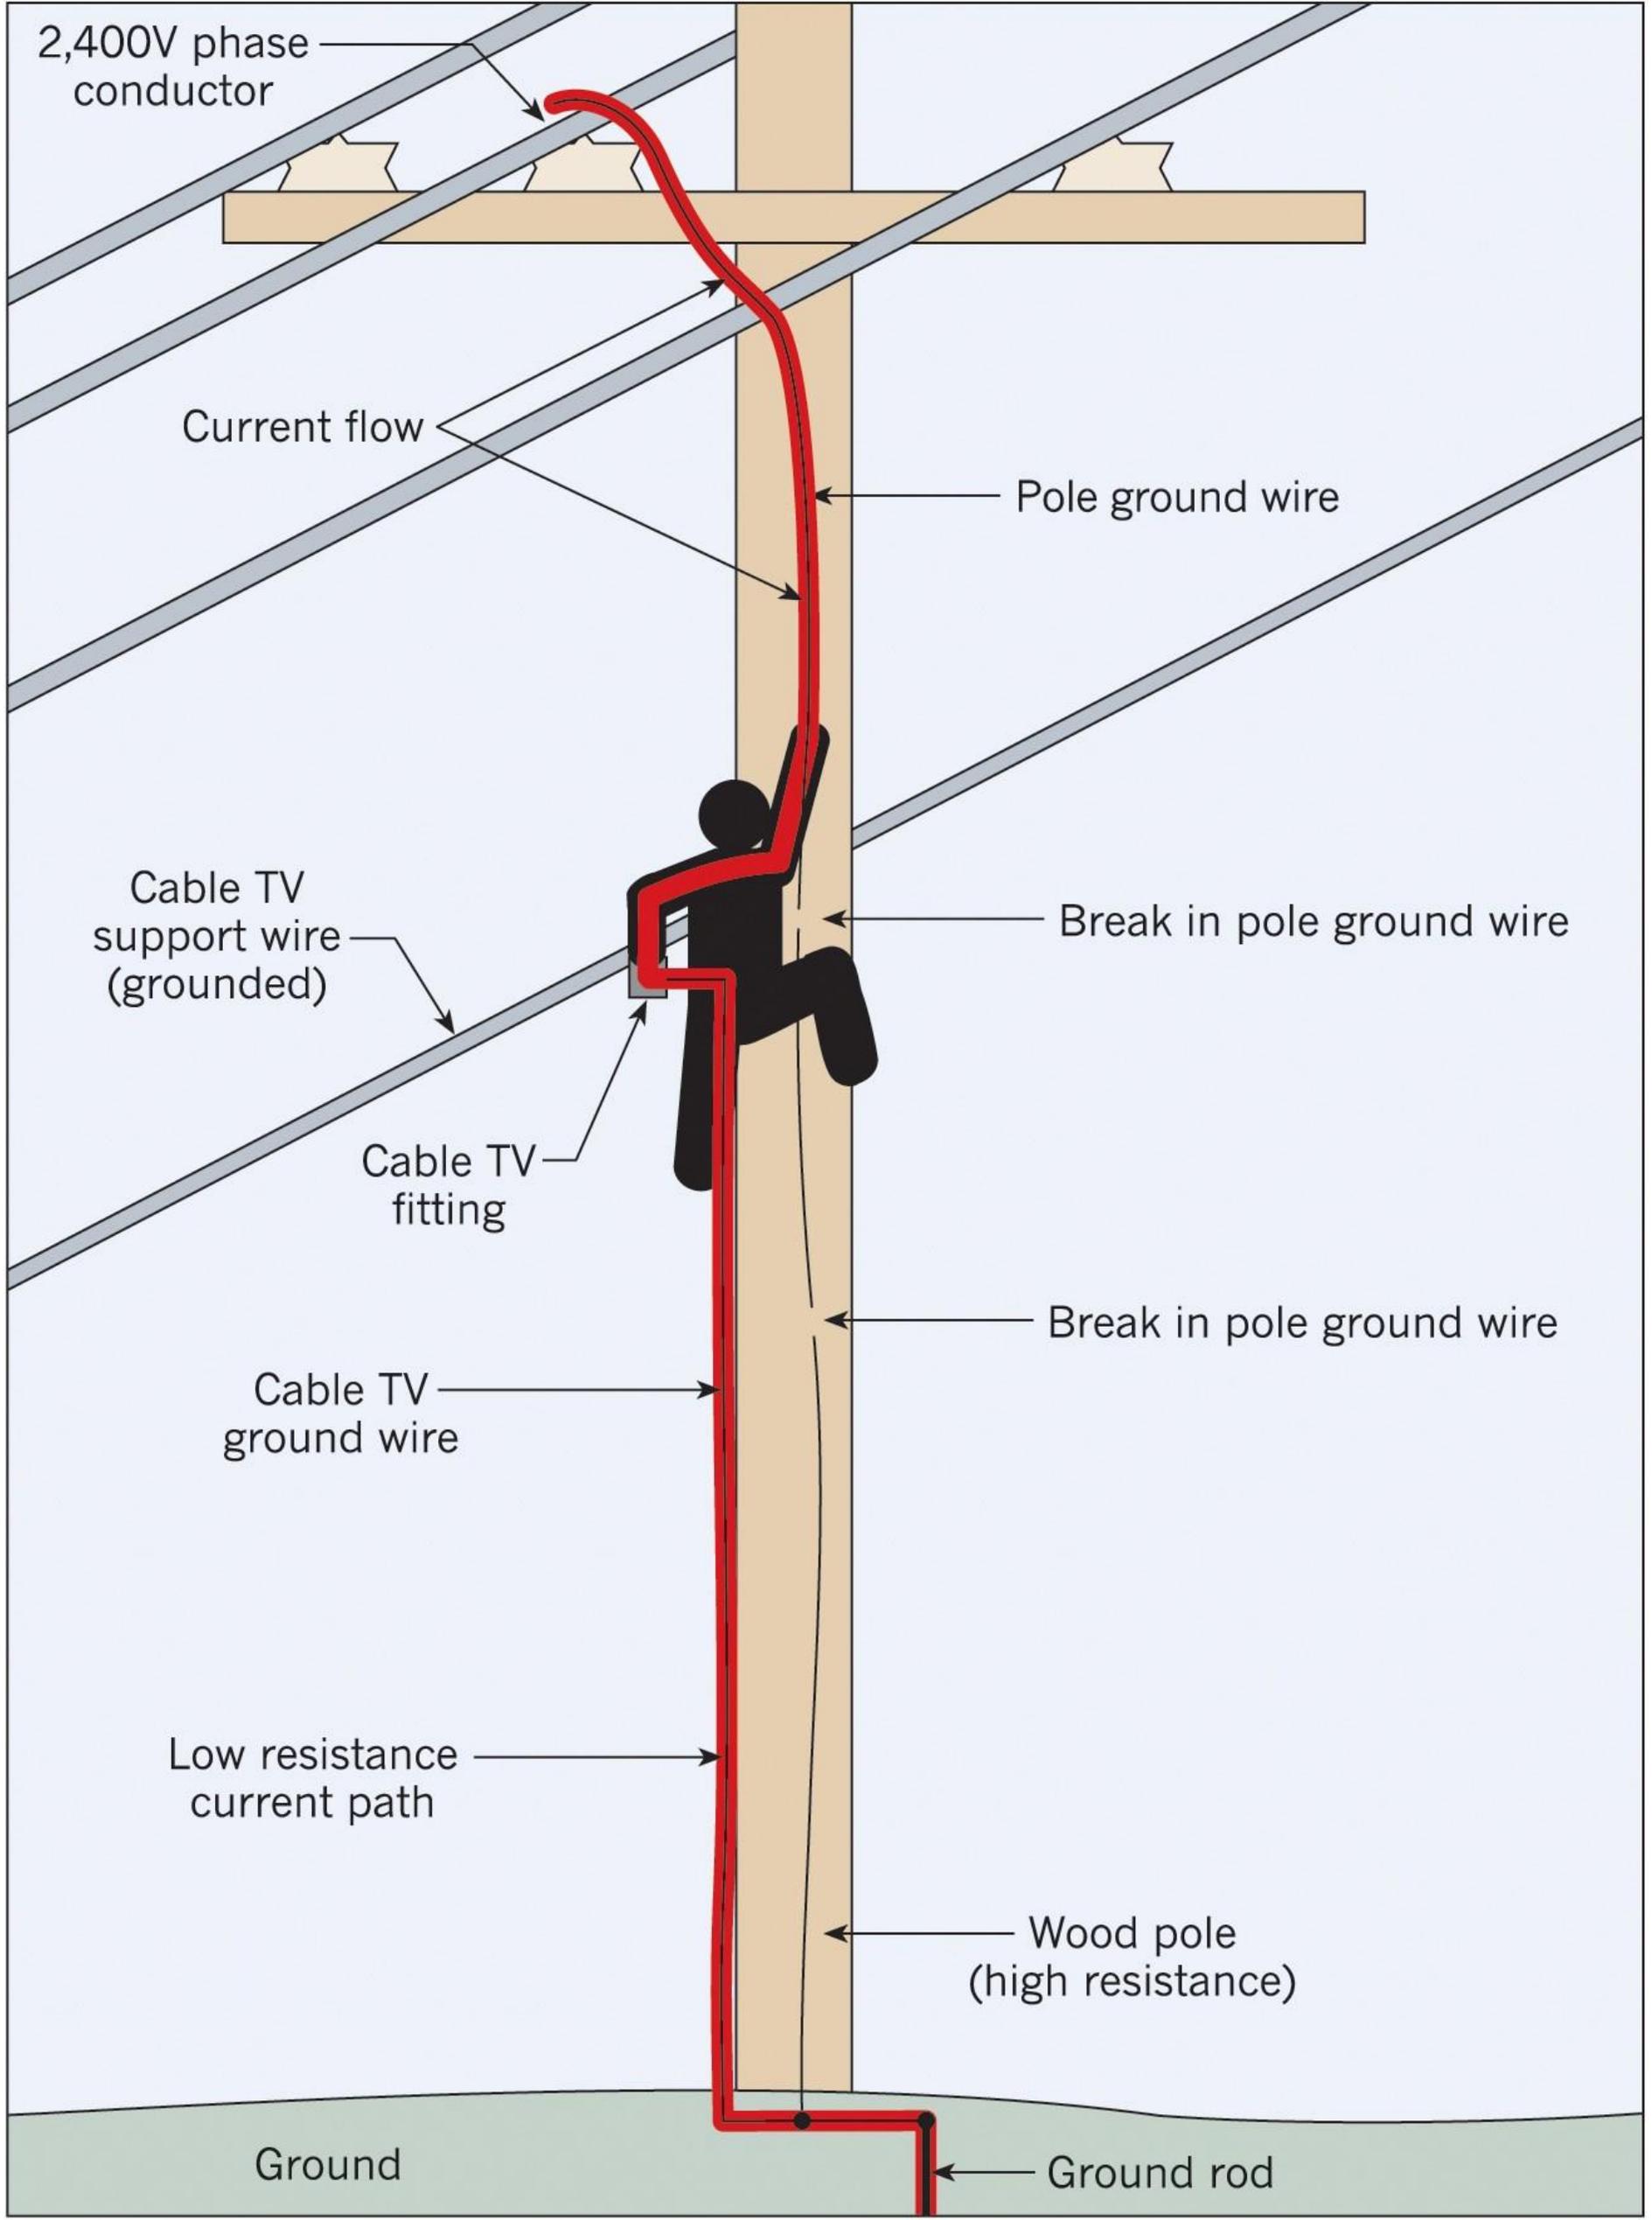
The setting of this tragic accident occurred at an electric utility pole, similar to the one depicted in the **Figure** below. The technician was standing near the top of a ladder (the ladder is not shown so you can more clearly see the current path). On the left side of the pole, you see a cable TV wire and fitting attached to a grounded steel support wire. The fiberglass

The heavy red line depicts the current path that ultimately killed a cable television technician.

An examination of the wood pole by electric utility personnel revealed that a ground wire ran up the east side of the pole from the ground level. However, as the investigating utility electrician followed the ground wire up the pole, he realized it had been cut in two places — 6 ft and 10 ft above ground level — and that the top portion of the wire was hanging in mid air (less than 1/4 in. away from the 2,400V phase conductor at the top of the pole).

At the time of his inspection, the electrician noted current was “jumping across” from the live phase conductor to the end of the ground wire. He measured approximately 880V between the ground wire on the pole and the steel wire supporting the TV cable. He concluded that the energized phase conductor had induced the 880V on the ground wire due to its close proximity. In addition, he noted the steel wire supporting the TV cable and fitting registered 0V — as it should have, due to the fact that it was grounded.

Based on the evidence, I came up with the following conclusions regarding how the accident played out. The cable TV technician climbed up his fiberglass ladder, which was resting against the west side of the electric utility pole, to remove the filter from the TV cable fitting supported from the pole. Because the fitting was above the end of the ladder, he would have had to reach up and out to work on it. He most likely steadied himself against the pole by reaching around it with one hand as he reached out with his other hand to the TV cable fitting to remove the filter. When he had difficulty removing the filter, he probably reached further around the pole to better steady himself. It was at this point that he must have made contact with the energized ground wire, which carried some voltage (880V or higher, depending on how close the loose ground wire at the top of the pole was to the energized phase conductor).

The pattern of burns on the victim's hand were consistent with placing the hand at almost a 45° angle with the vertical against the pole covering the ground wire, as one would do to steady oneself. This would have placed his upper body in the current path between the energized ground wire and the grounded cable TV support cable. The passage of current through his body either caused his death or caused him to fall to his death (see Electrical Circuit Phenomena on page 10). The location of his body, as found on the ground at the base of the pole, was consistent with him leaning out (to the north) to work on the cable fitting. An examination of the deceased's hands showed no evidence that he had attempted to break his fall, indicating that he was either dead or unconscious prior to hitting the ground.

As shown in the first **Figure** above, when the victim contacted the energized ground wire above the cut sections and the grounded cable support wire at the same time, the current flowed into his hand touching the energized ground wire, through his body, out his other hand to the cable TV support cable, and then through the cable TV ground wire to ground. The burn marks on his hands confirmed this path.

The cause of the accident was attributed to poor housekeeping by the municipal electric utility, as was evidenced by the hanging, disconnected (but apparently still energized) service drops on this pole — not to mention the manner in which the ground wire had been cut and not removed
